*A case study of land treatment in
a cold climate—West Dover, Vermont*

CRREL Report 82-44

December 1982

J.R. Bouzoun, D.W. Meals and E.A. Cassell

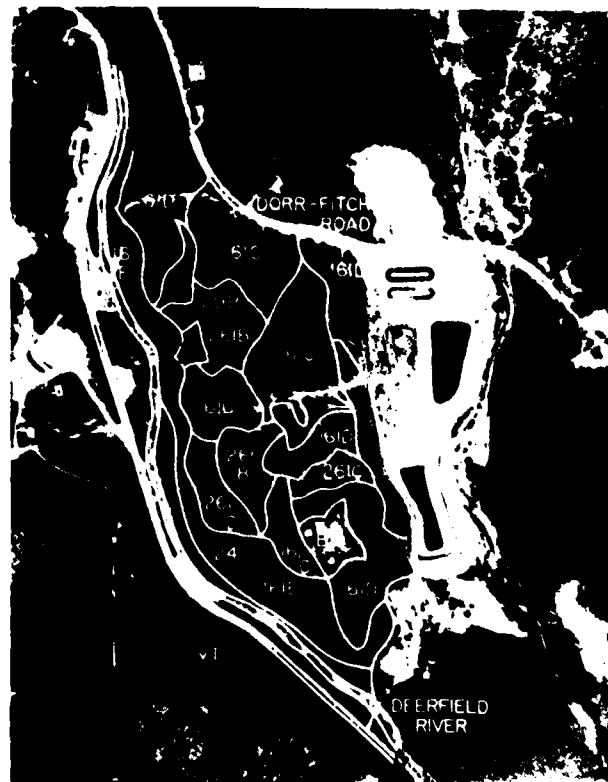
Figure 9. Detailed soils map of West Dover facility.

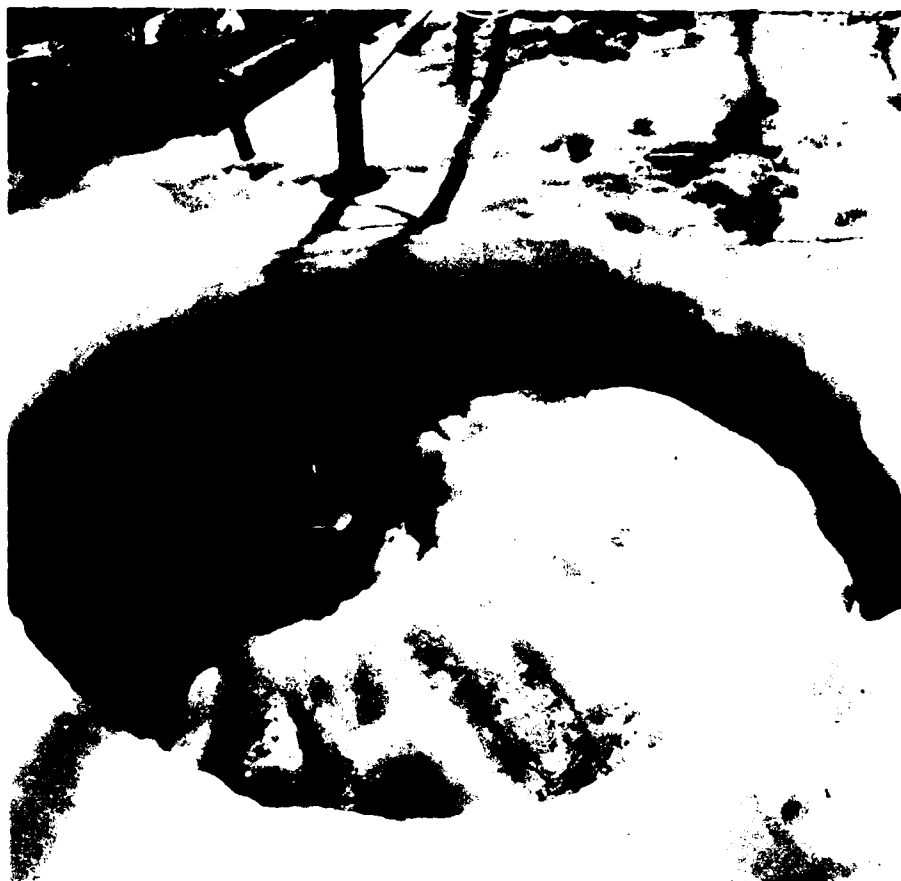
a. Lateral 2.

Figure 11. Downward spraying nozzle.

b. Lateral 8.
